Firvale Wilderness Camp
4330 Highway 20
Firvale, BC

April 28, 2022

Re: Ratcliffe Creek Stream Channel Remediation
Construction Review

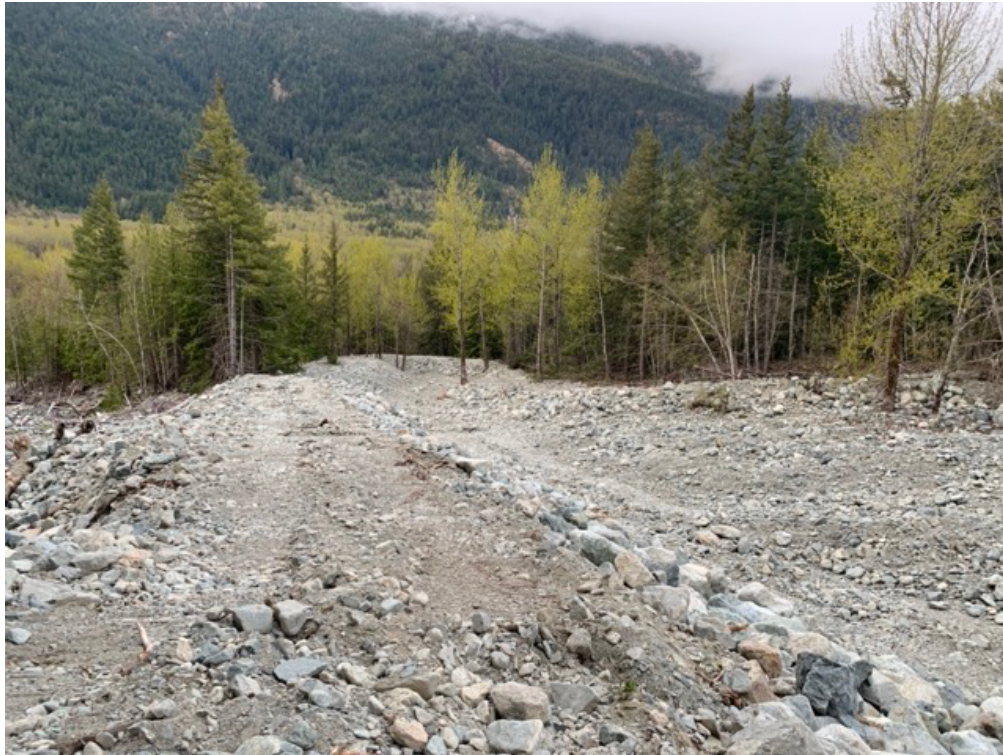
Photo 1 - East Channel cutoff from u/s

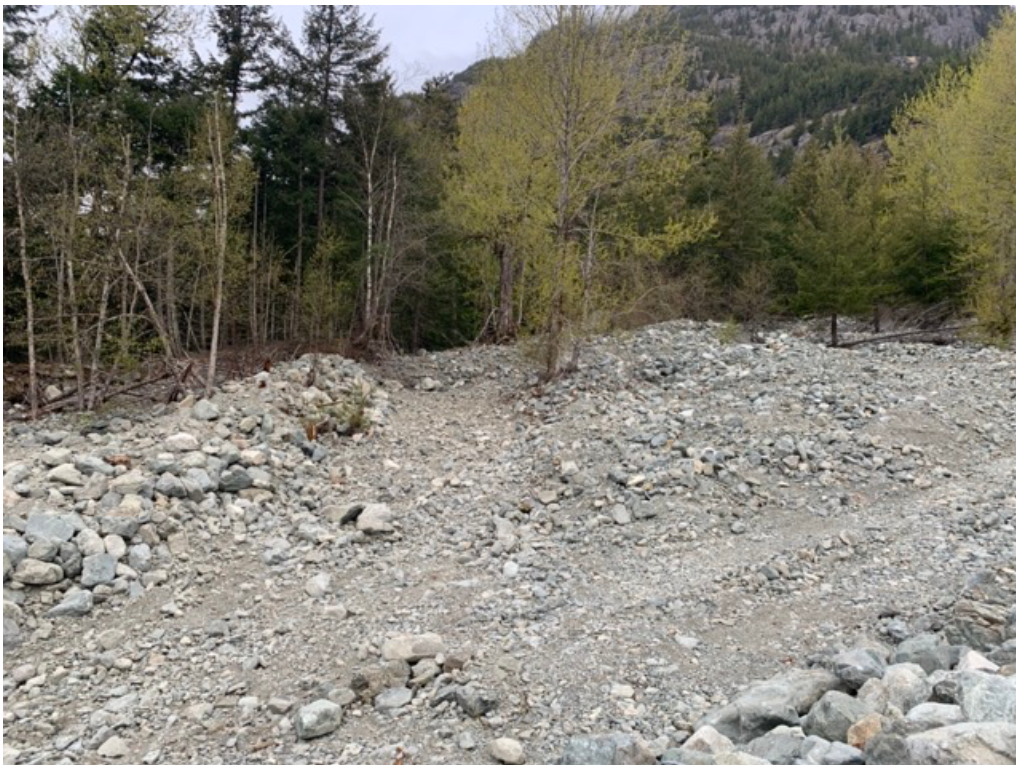
In our review it was recognized that the lower fan of Ratcliffe Creek has been subject to multiple historic avulsion events where the creek has partially or wholly diverted from its established location, causing flooding and erosion on the property to the west. Furthermore, some of the more recent and significant flooding was observed to have originated on the western bank upstream of the east channel cutoff. It is our opinion that a significant portion of the recent flooding that occurred to the western property was natural and unrelated to the east channel cutoff constructed in 2019. Nevertheless, to help mitigate this circumstance, the western berm was extended 25m in a best effort to address the historic point of avulsion.

Photo 2 - Extension of west berm to cutoff avulsion point

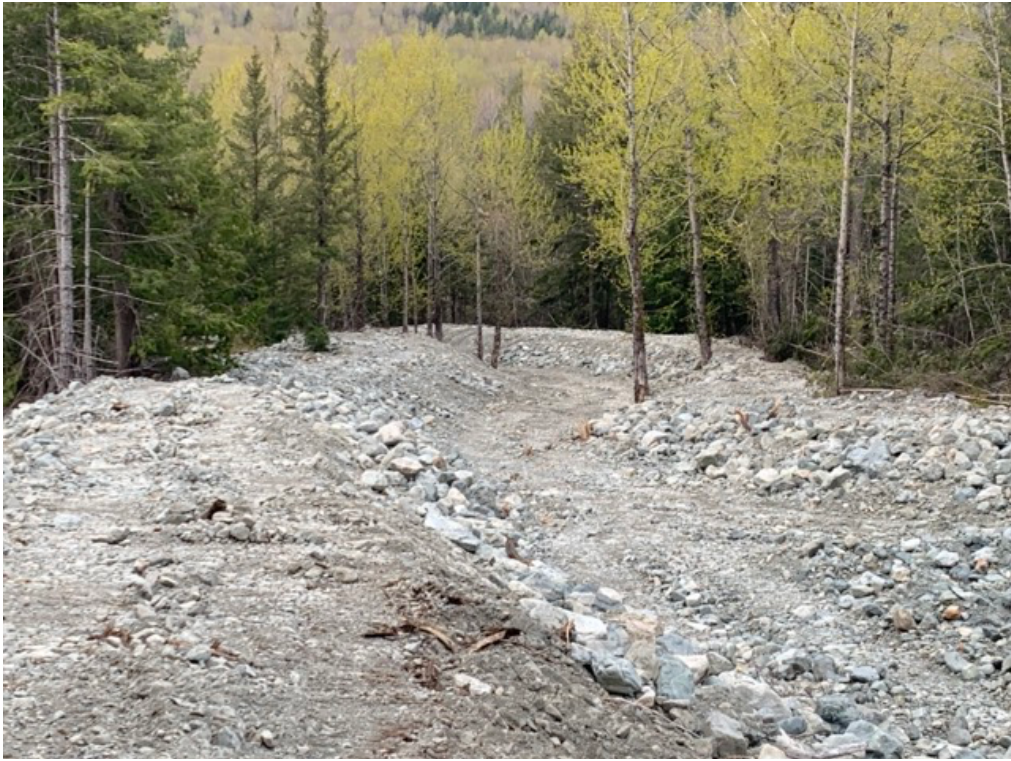
Photo 3 - Upper west channel looking d/s

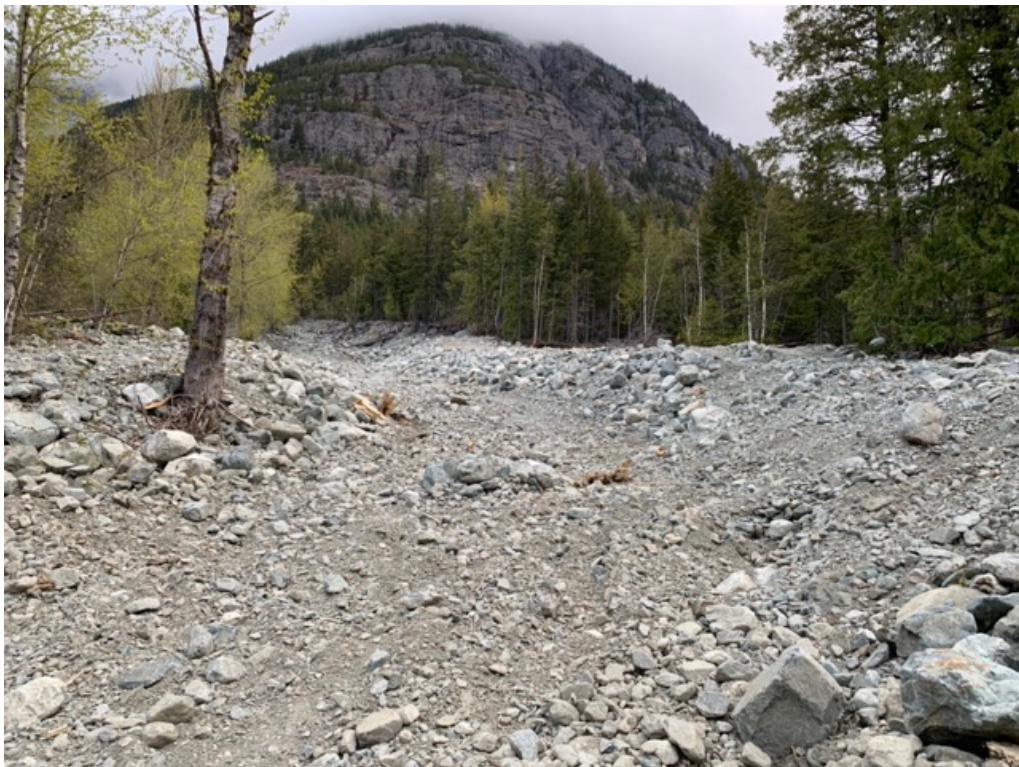
Photo 4 - West Channel looking u/s from end of East Channel cutoff

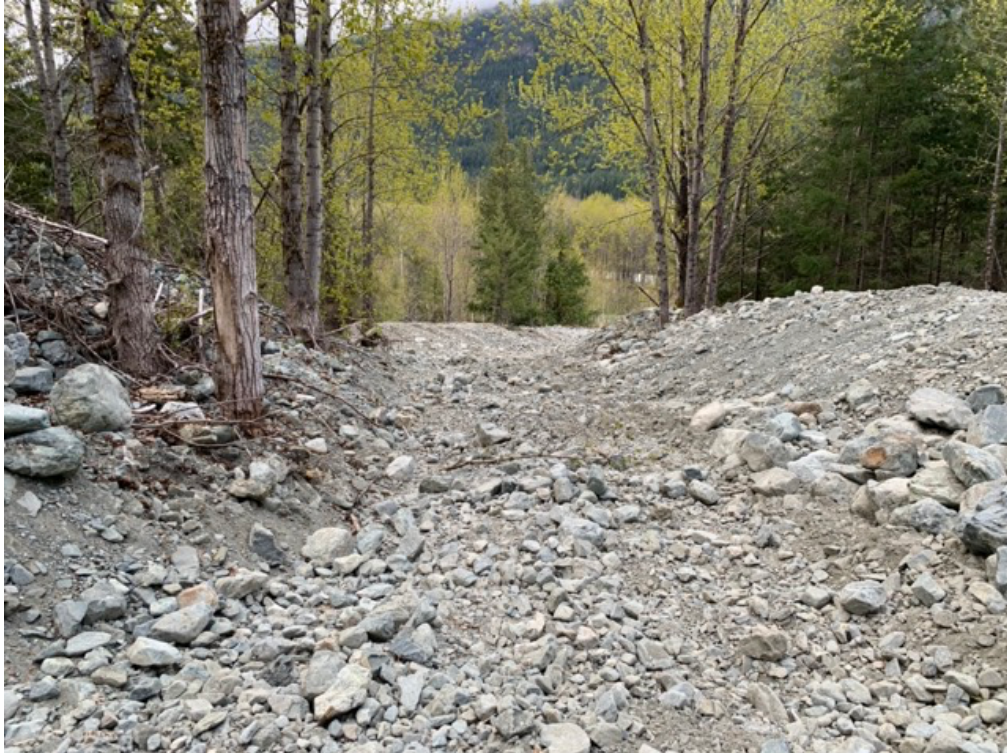
Photo 5 - West Channel looking d/s

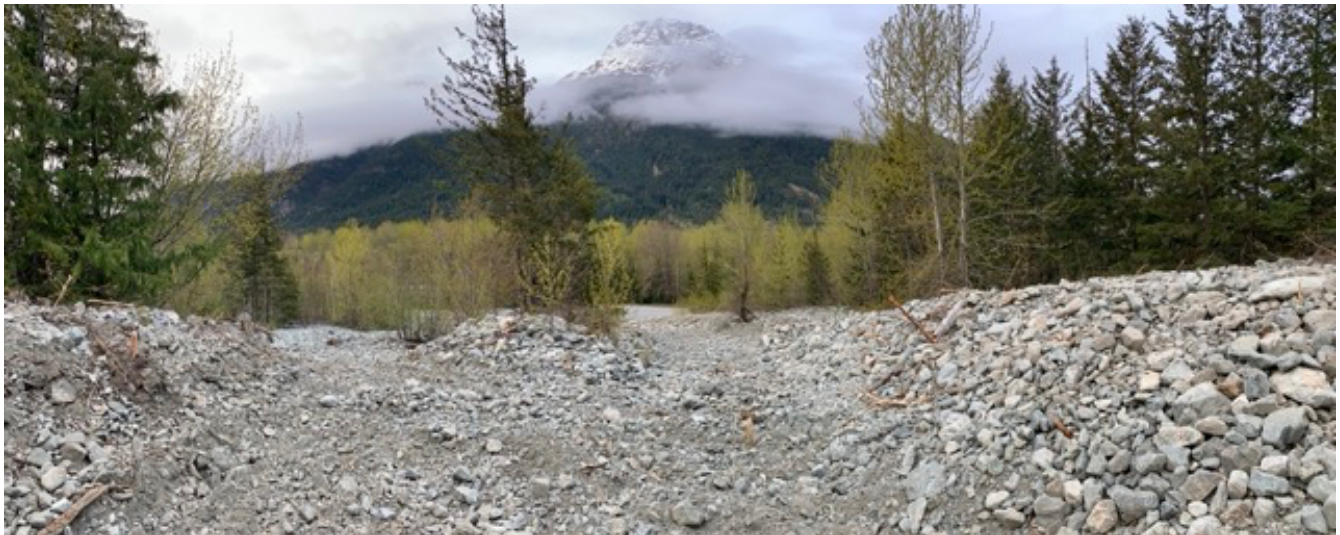
Photo 6 - West Channel bifurcation looking d/s

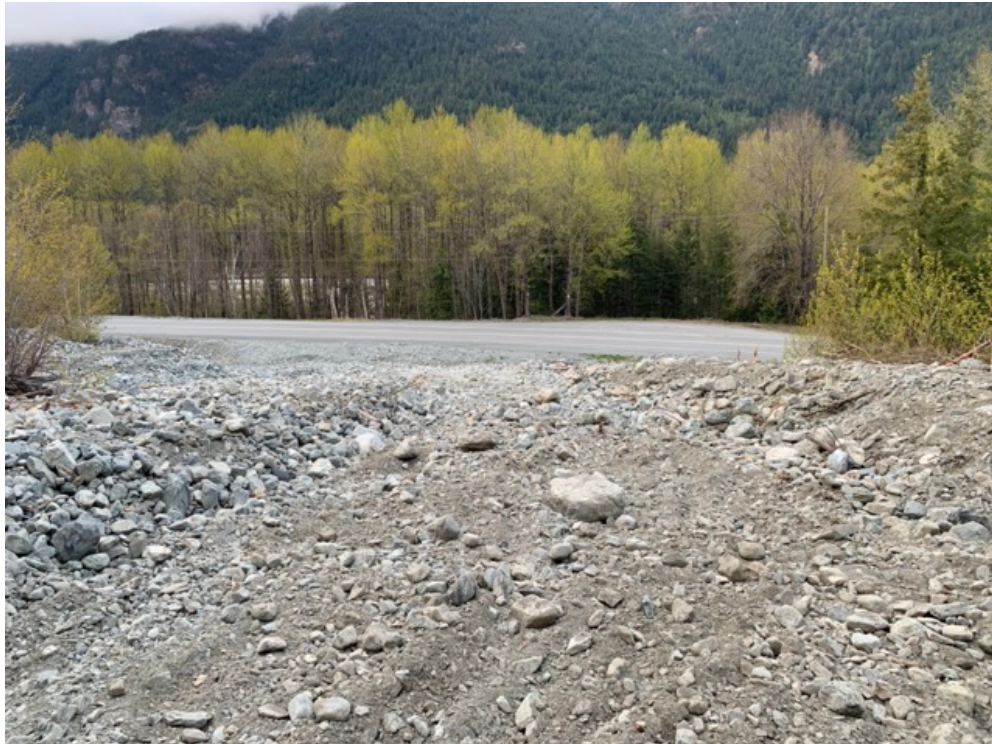
The function of the completed works in mitigating flooding of the property to the west and the highway will be contingent on available storage within the debris basin and on the continuing capacity of the east culverts. To ensure their continuing service, it is expected that intermittent debris removal and ditching by the highways maintenance contractor will be required.

Photo 7 - End of West Channel berm and developed debris basin

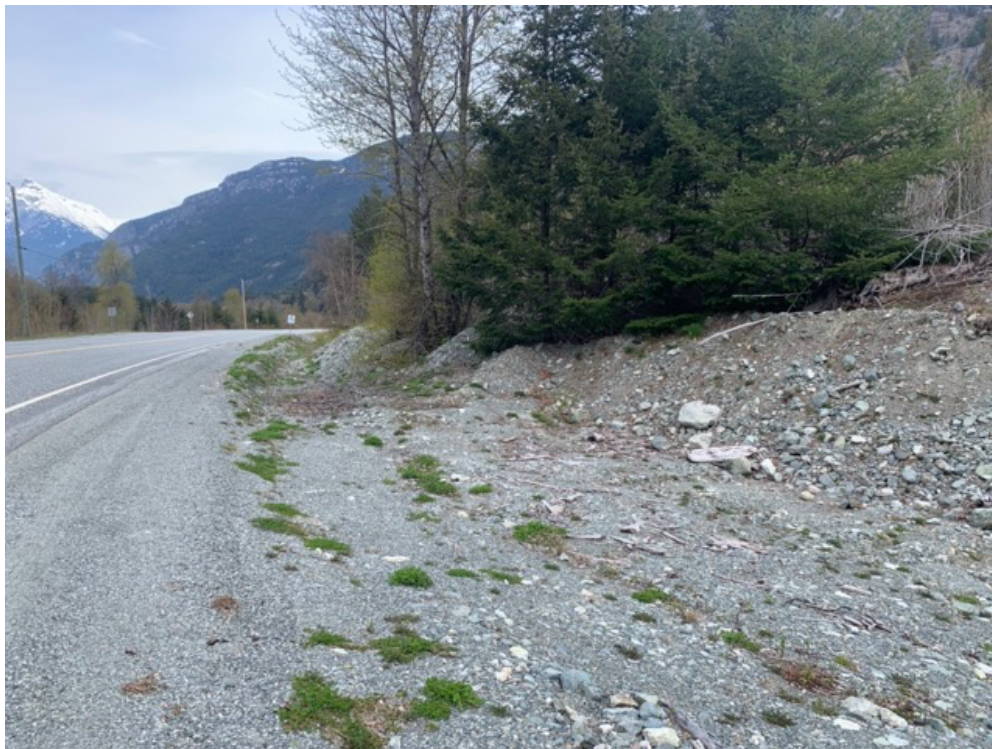
Photo 8 - Existing ditch block

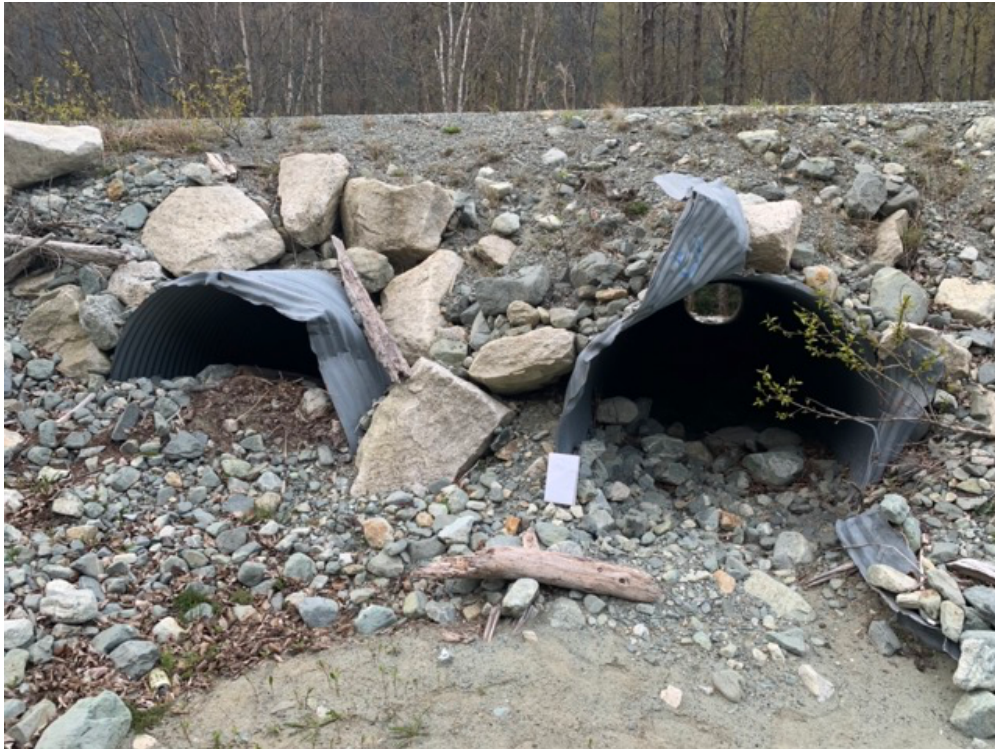
It was also recognized that the two east culverts that convey Ratcliffe Creek under Highway 20 are presently partially blocked with debris; reducing their capacity by 25% and 50% respectively. This issue will tend to cause a backup of flow in the highway ditch and likely result in the deposition of material that would normally clear if the culverts were fully open. It is recommended that the maintenance contracted be requested to clean the two inlets to re-establish free flowing conditions.

Photo 9 - East culverts inlet blockages

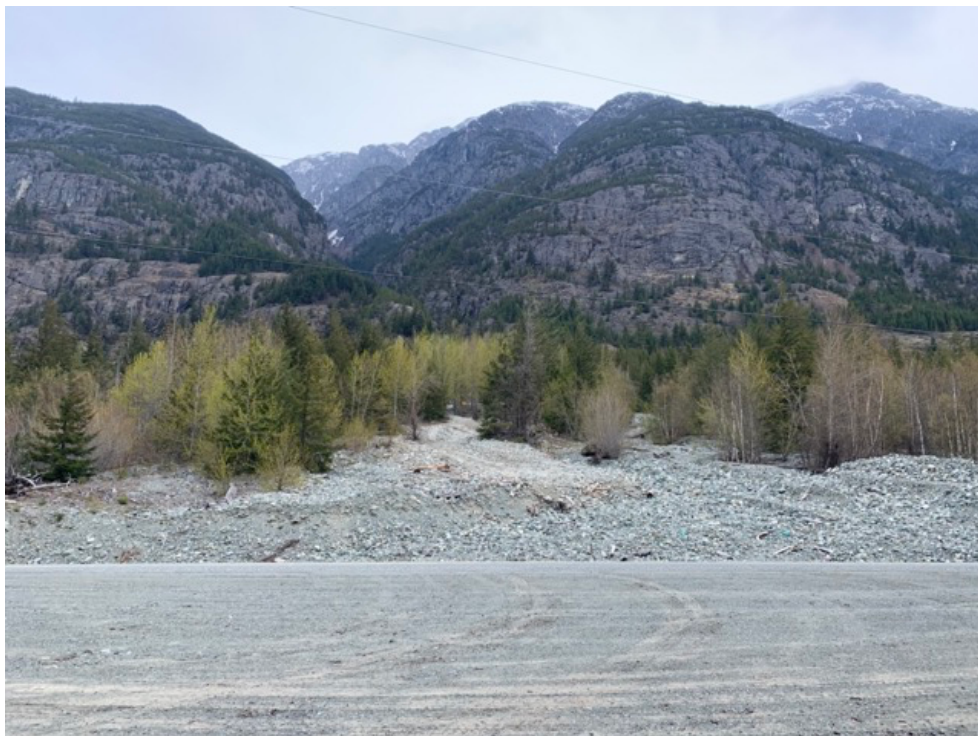
Photo 10 - Ratcliffe Creek lower fan looking u/s
