Bella Coola Airport Central Coast Regional District

**Airfield Pavement Condition Assessment
Final Report | May 28, 2025**

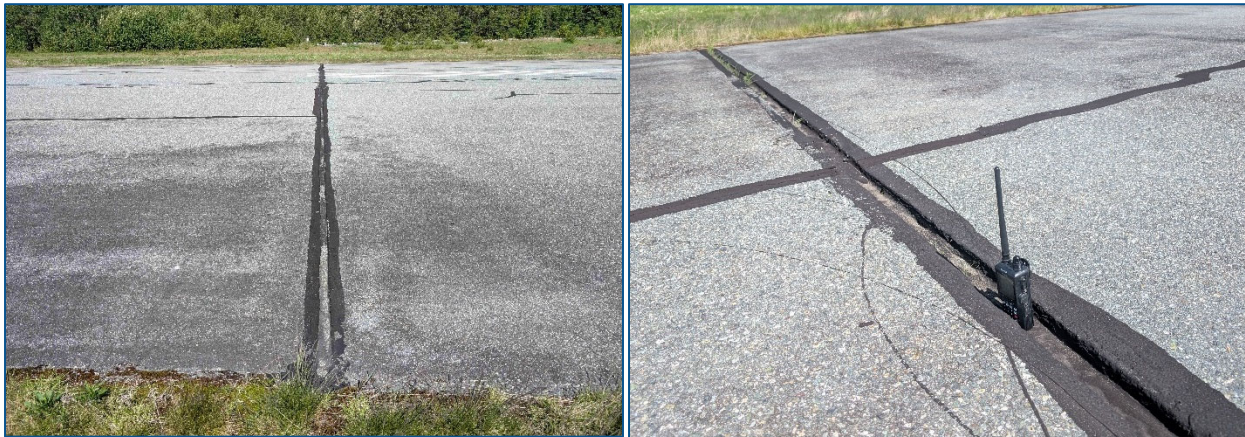
Runway 05-23 was observed to be in **Poor Condition** and should be rehabilitated in the short term. Non-uniformly distributed transverse cracking was observed throughout Runway 05-23. As well, uniformly distributed longitudinal cracks were observed along existing paving lanes. Most of the identified cracks were sealed through The CCRD's preventative maintenance program, which is the primary treatment technique for this type of surface defect.

Specifically, twelve (12) non-uniformly distributed high severity transverse cracks were observed during the visual condition assessment. The widths of the transverse cracks generally range from 1.5 to 2 inches. Depending on the chosen rehabilitation strategy, these transverse cracks should be locally repaired during construction.

Samples of transverse cracking

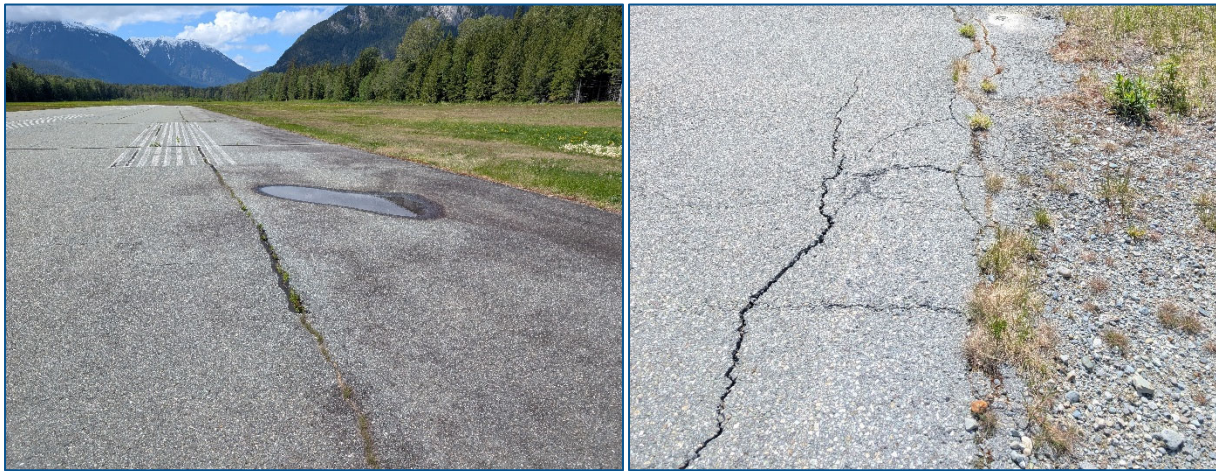
Evidence of edge cracking, vegetation growth, and localized ponding were each observed near the threshold of Runway 05.

Minor Evidence of Vegetation Growth & Ponding (Left) Edge/End Cracking (Right)

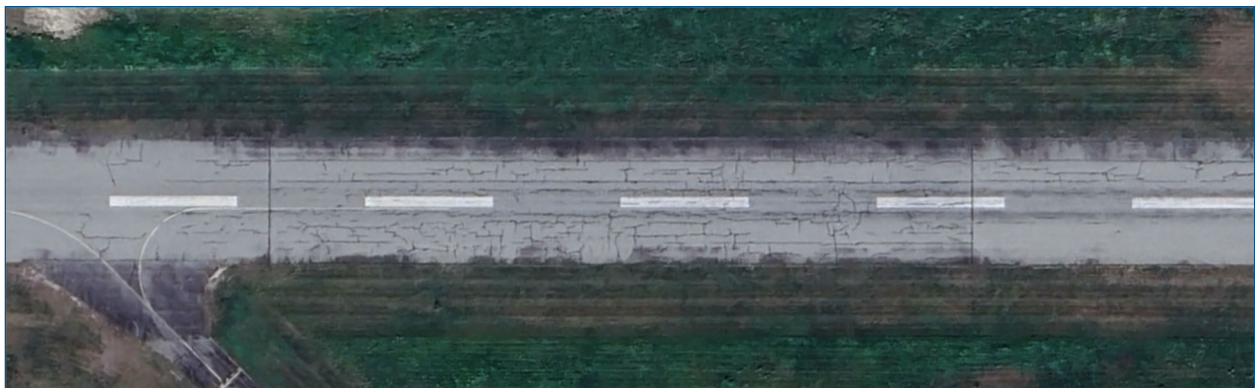
In addition, there was a particular section of Runway 05-23 that was observed to be **Very Poor Condition** compared to the remainder of the surface which was observed to be in **Poor Condition**. This area is located east of the Taxiway Bravo connection to Runway 05-23 and spans approximately 170 m toward Taxiway A and the threshold of Runway 23 and is shown below in an aerial image. Depending on the preferred rehabilitation strategy, this area may be a candidate for more extensive rehabilitation efforts compared to the remainder of the runway, taxiway and apron areas.

Runway 05-23 – Section in Very Poor Condition

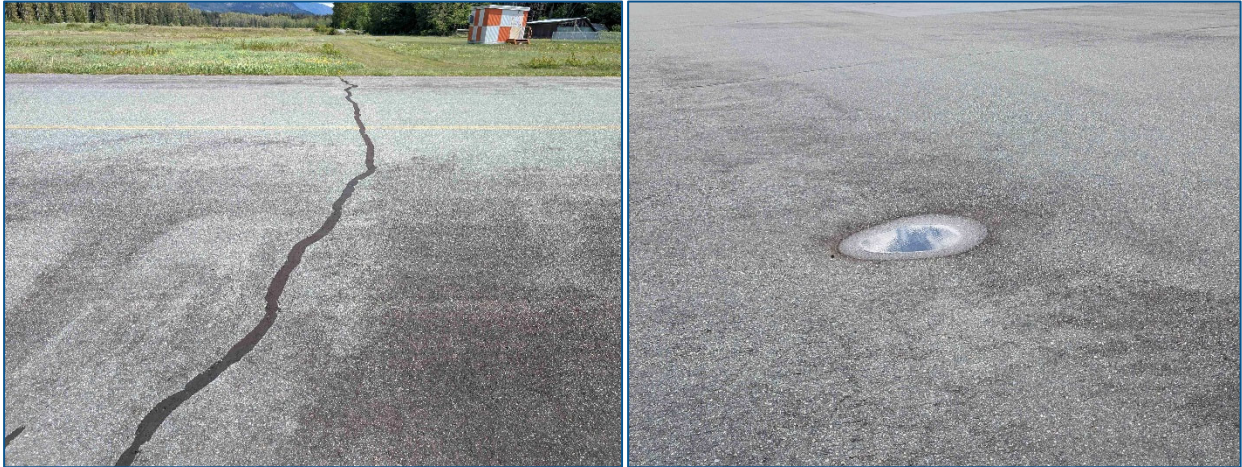
Taxiway A connects Apron I to the displaced threshold of Runway 23 and measures approximately 50 ft. (15 m) in width. Taxiway A was constructed in 1978 and was last rehabilitated in 1996 through a pavement overlay project. Taxiway A was observed to be in **fair condition** with two (2) transverse cracks: one located at the paving joint/lane with Runway 05-23; the other located near the mid-section of the taxiway. In addition, minor evidence of localized ponding was observed. While the surface was observed to be in fair condition, it has been nearly 30 years since the surface was last rehabilitated and therefore would benefit from modest rehabilitation efforts (i.e. a mill and pave or pavement overlay).

Sealed Transverse Crack (left) and Low Severity Ponding (right)

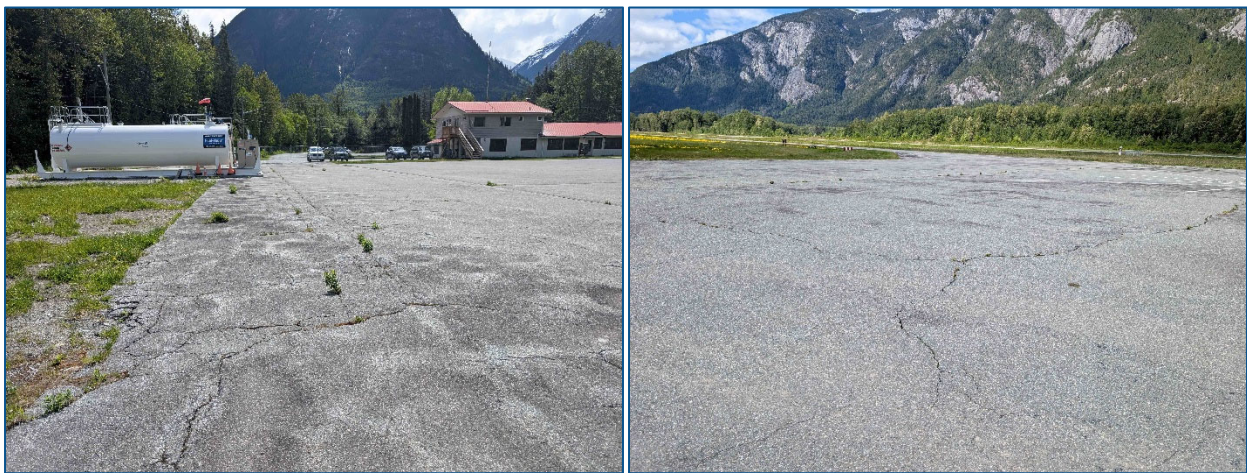
Apron I is used for aircraft parking, fuelling, loading and unloading, and access to the terminal facility. Tie-down facilities to support itinerant aircraft are provided along the western edge of Apron I while fuelling operations are situated on the eastern edge. Apron I was observed to be in **poor condition** and is recommended for rehabilitation in the short term. Apron I had similar pavement surface deficiencies as compared to Runway 05-23 and Taxiway A, including:

- Discrete cracking;
- Vegetation Growth;
- Select locations where evidence of ponding has occurred; and
- Tie-down anchors that appear to have decayed and are recessed into the pavement structure, rendering them unusable;

Pavement Repairs (left) and Recessed Aircraft Tie-Down Anchors (right)
