Firvale Wilderness Camp
4330 Highway 20
Firvale, BC

April 28, 2022

Re: Ratcliffe Creek Stream Channel Remediation
Construction Review

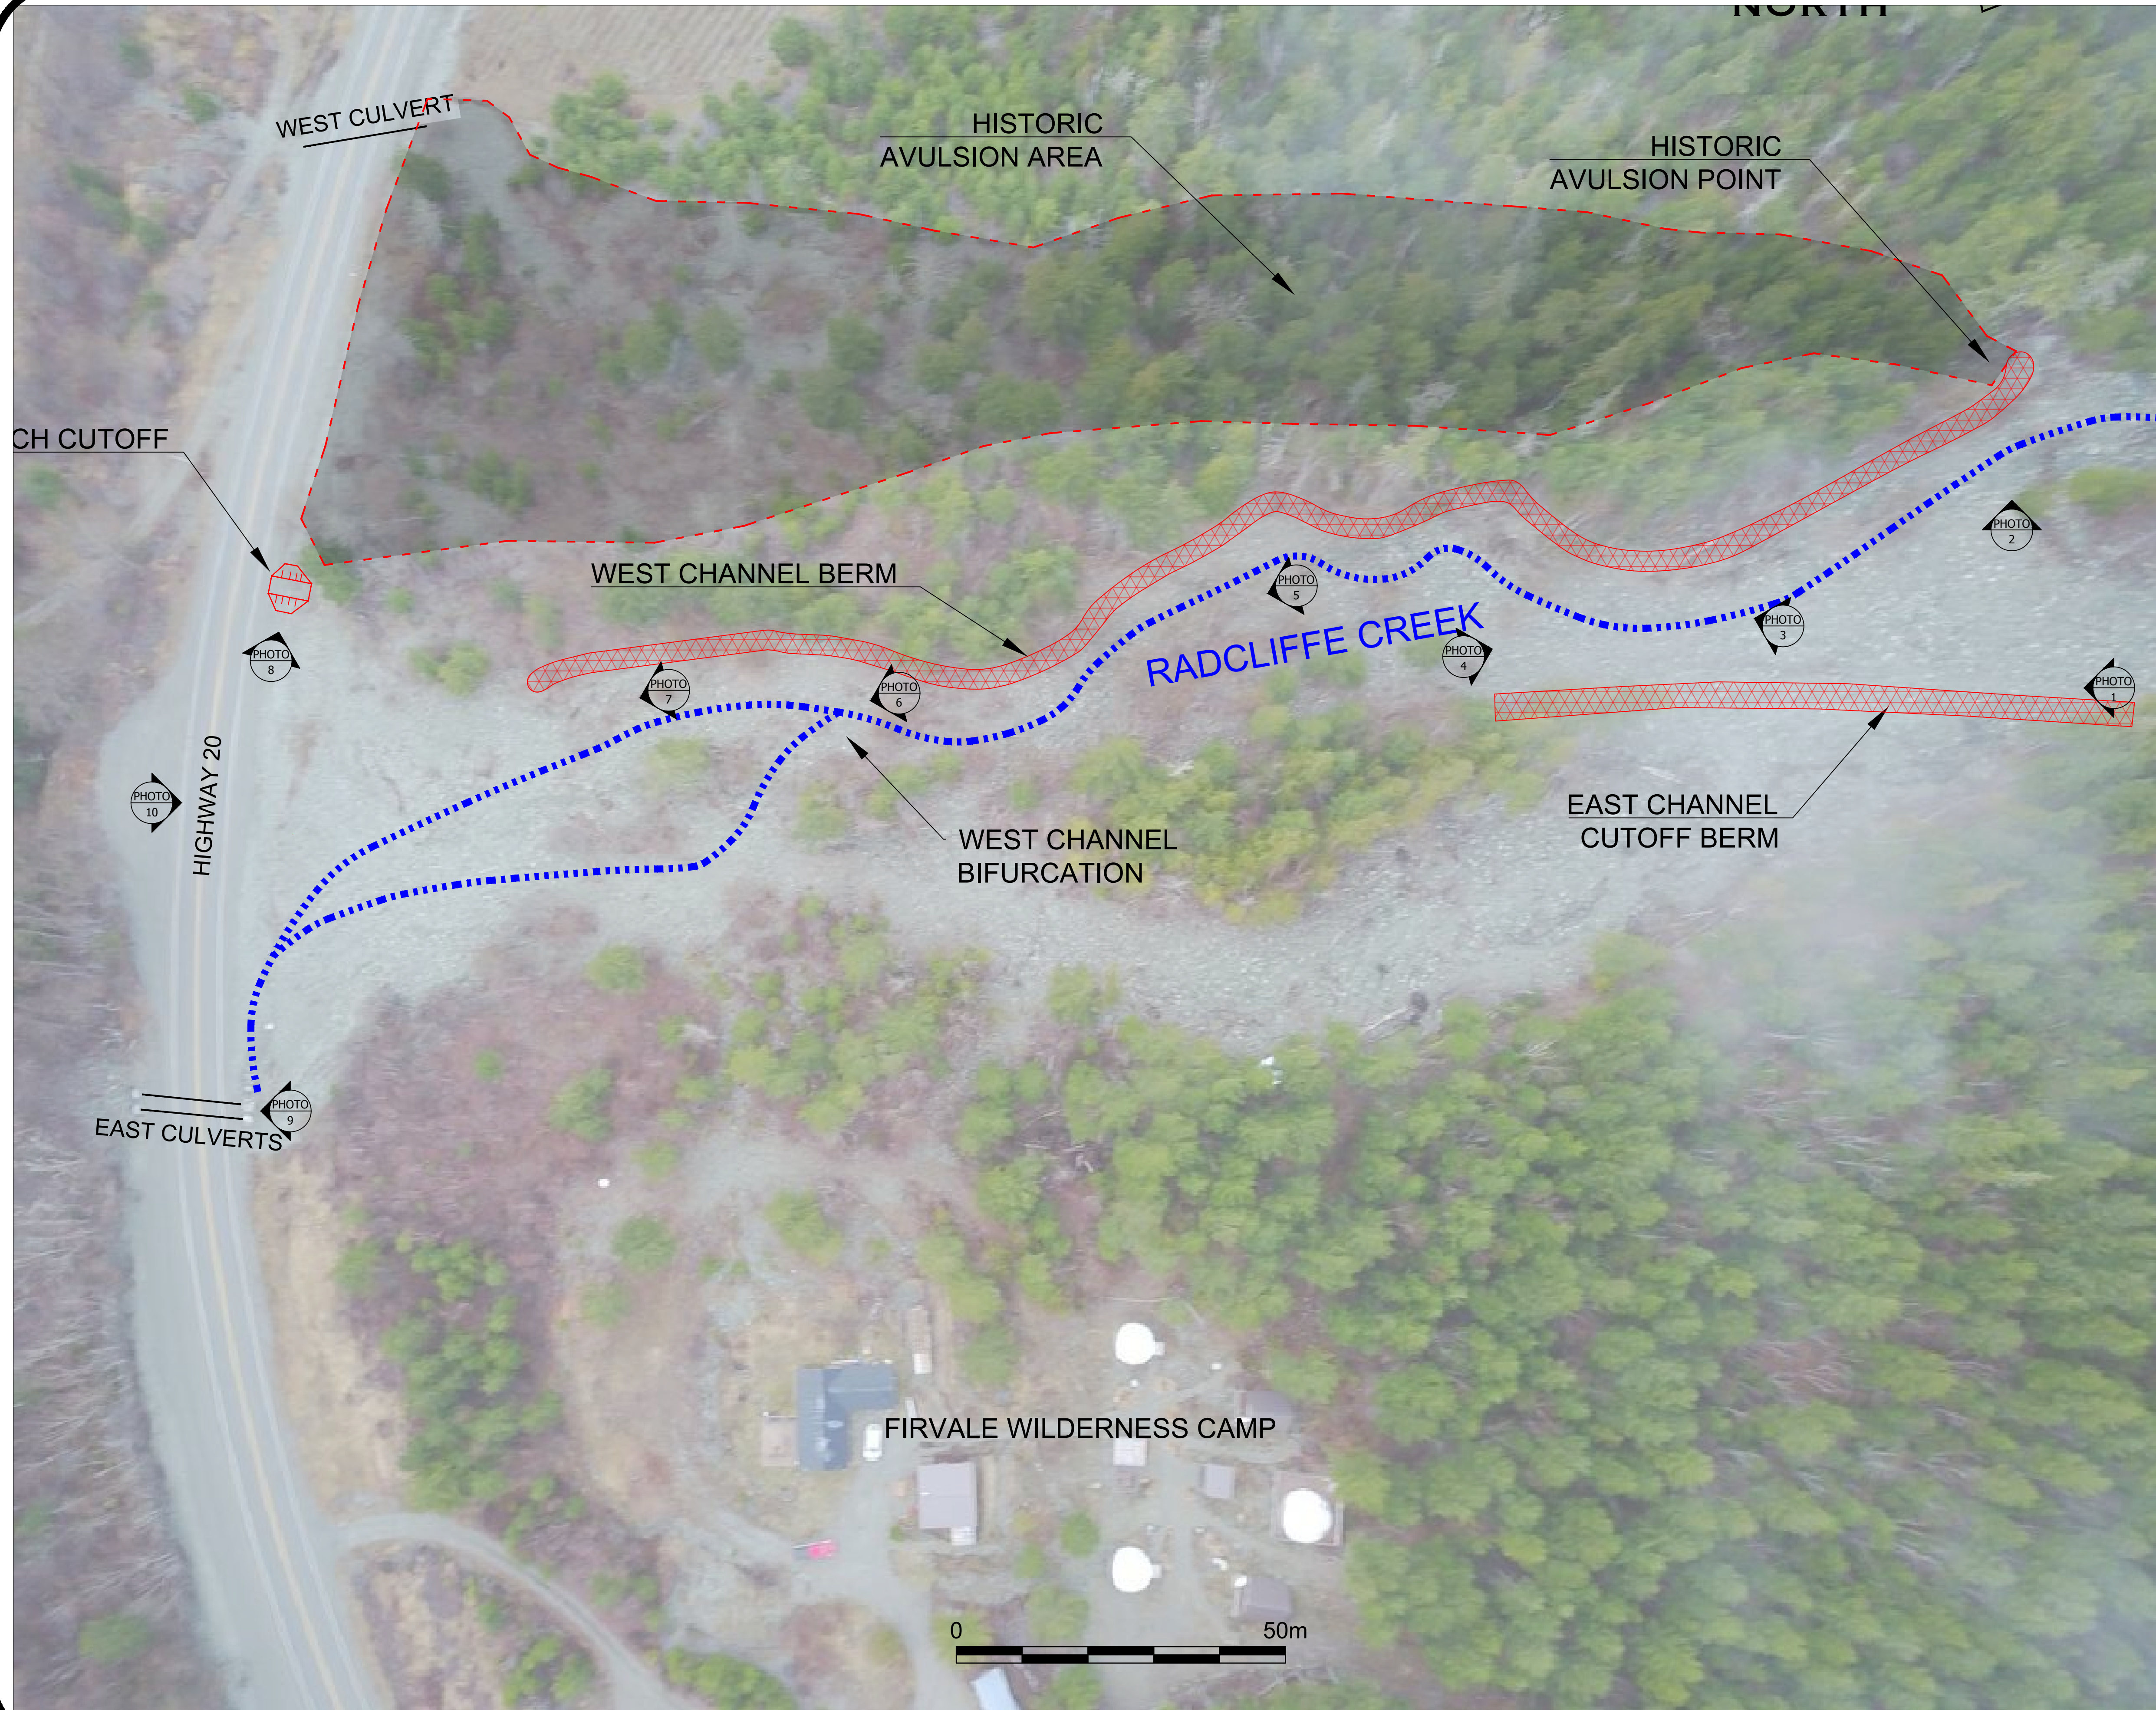
RATCLIFFE CREEK CHANNEL REMEDIATION
FIRVALE WILDERNESS CAMP, FIRVALE, BC
FIGURE 1

Photos are presented in the Appendix with their locations and orientation referenced in Figure 1.
